## Stucco Failures and Remediation

Roger G. Morse AIA, and Paul E. Haas CSP, CIH

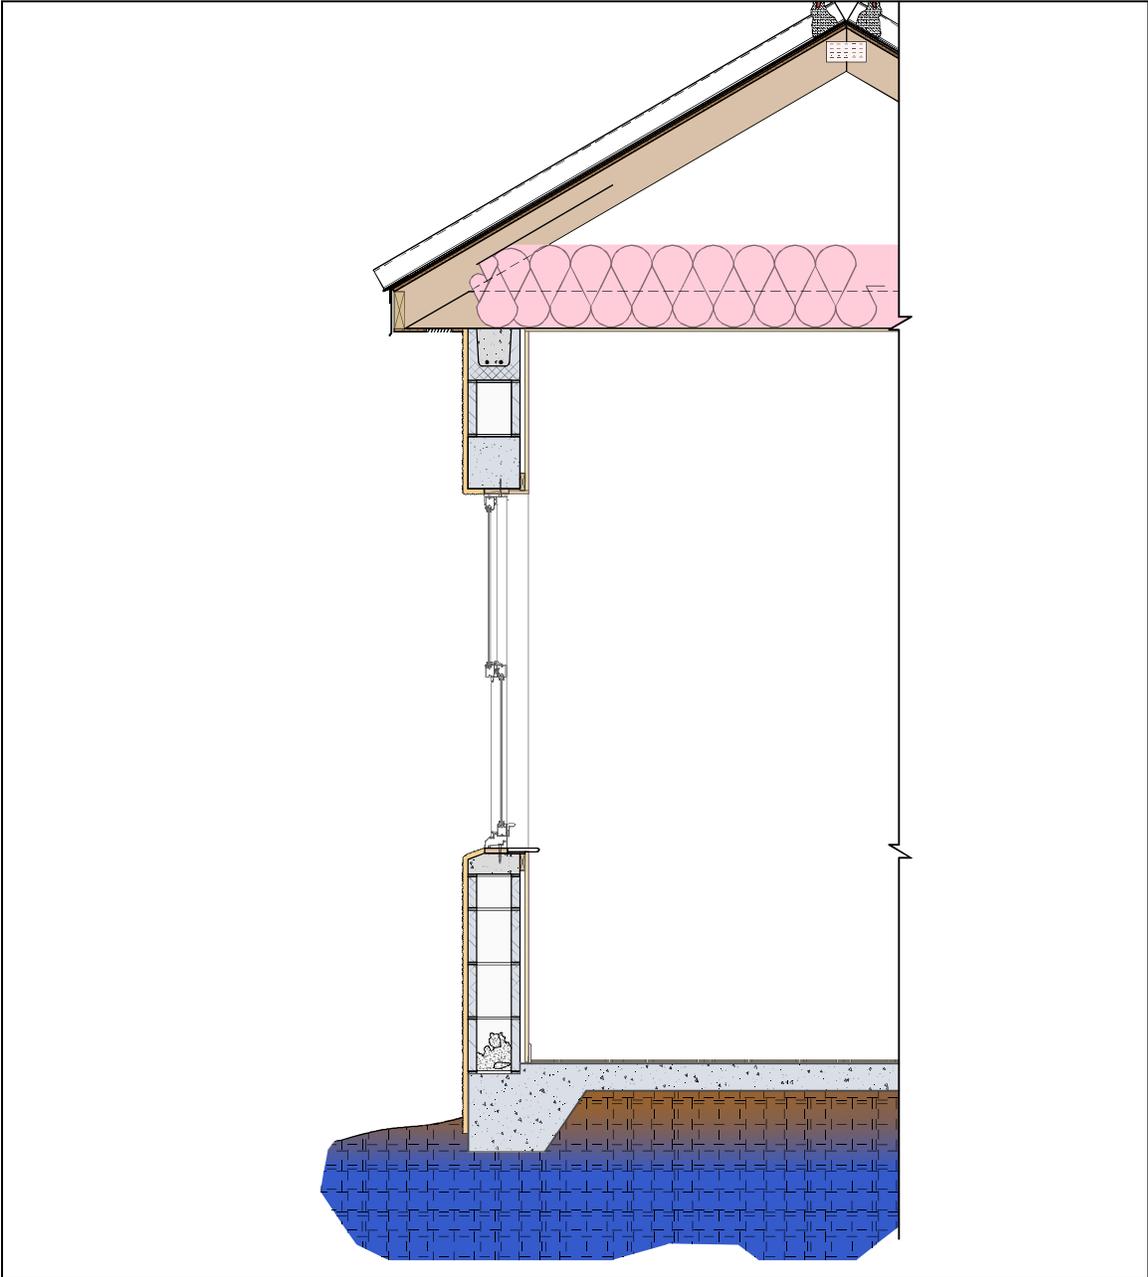
Drawing 1: Typical Florida Building Wall Section

Typical Florida building construction is illustrated in **Drawing 1: Typical Florida Building Wall Section**. As can be seen, a typical low-rise Florida building has no foundation or basement; rather, the building is built on a slab. The slab edges are haunched down to produce a thicker area at the edges of the slab. This provides the foundation for the masonry walls that carry the loads of the roof and second floor, if there is one. A concrete tie beam is poured at the top of the wall, and this tie beam is tied to the slab with reinforced concrete poured in the hollow cores of the block walls, typically on either side of windows and doors, at corners, and at intervals along walls. Roof joists are then anchored to the tie beam with steel strap anchors. This results in a strong reinforced concrete framework that is able to resist the applied forces of a hurricane. The masonry-and-stucco exterior is also able to resist penetration of wind-blown debris during wind events.

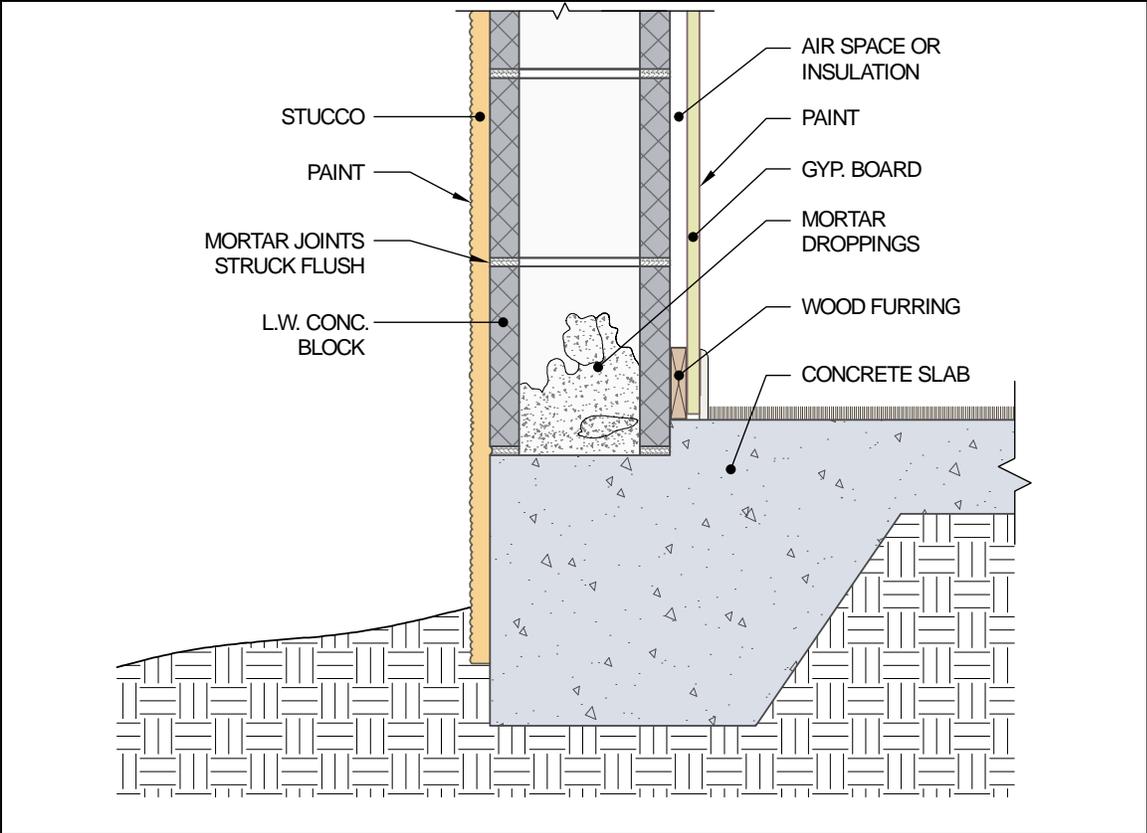
Drawing 2: Base of Exterior Wall of Typical Florida Building

**Foundations and Floor.** As there is no frost in Florida and there is high groundwater, buildings are typically built without foundation walls or basements and are instead supported on concrete slabs. This construction is shown in **Drawing 2: Base of Exterior Wall of Typical Florida Building**. To prevent the edges of the slab from becoming undermined and to provide additional structural support, the edges of the slabs are “haunched” down to make the perimeter of the slab thicker than the center. This “haunched” section carries the weight of the masonry exterior walls as well as floor and roof loads transmitted through the masonry walls. The top surfaces of the slabs are stepped down on the perimeter to form a shelf for the installation of concrete block, so that the concrete block in exterior walls starts at about one and one-half to two inches below the inside floor slab elevation. The outside face of the concrete block is installed flush with the edge of the slab. Stucco is applied over the surface of the block and slab edge and extends below grade. No weep holes are installed in the base of the wall, so any water that infiltrates into the wall settles through the hollow block cores to the base of the wall, where it collects, potentially causing wetting of wall components. This source of wetting is ameliorated somewhat by the stepped-down block shelf in the slab, which results in less resistance to passage of liquid water to the outside through the relatively more porous concrete block and stucco than to the interior through the concrete of the slab. As the entire bottom of the wall can become wet due to this configuration, however, the concrete block and slab on the interior behind the drywall can also become wet, causing damage to wood bases, drywall, and floor finishes. Drywall is installed on either wood or metal furring attached to the inside of the concrete block, and is taped and painted to form an interior finish. Depending upon the quality level of construction, the air space between the gypsum panels and concrete block may be filled with insulation. Many types of insulation are used for this purpose; a common form of insulation is a reflective insulation comprised of multiple layers of aluminum foil or aluminized Mylar to create layers of relatively still air.

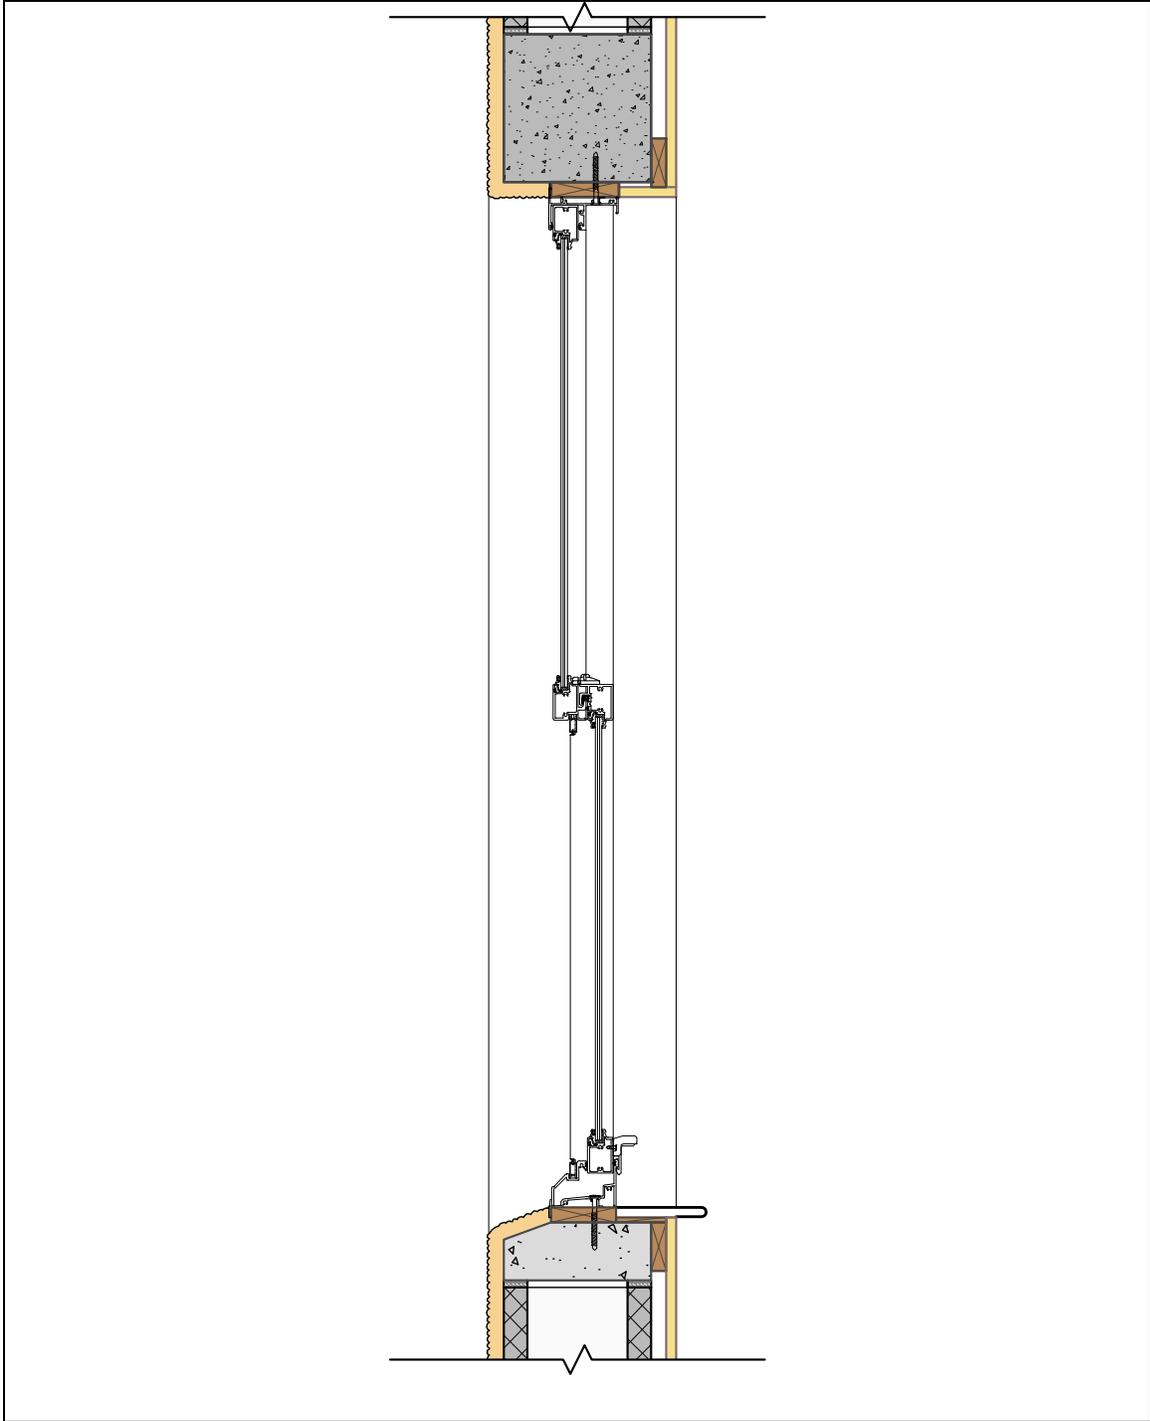
Drawing 3: Window in Typical Florida Building

control, however, this renders the situation fragile, as the wall operates at a moisture balance closer to failure, a situation that can easily lead to moisture problems. **Drawing 3: Window in Typical Florida Building**, illustrates window installation in a typical Florida building. First a masonry opening is prepared. This is accomplished by installation of jamb blocks with square ends on both sides of the opening supporting a precast concrete lintel. A precast concrete sill is installed in the bottom of the opening. Typically, this sill ends at each jamb, so there is a vertical joint at this location. There is no through-wall flashing at either the head or sill to direct water out of the interstitial spaces of the wall. Blocking is installed to accept a manufactured window unit. The head, jambs and sill are all covered with stucco and the joint between the stucco and window is caulked.

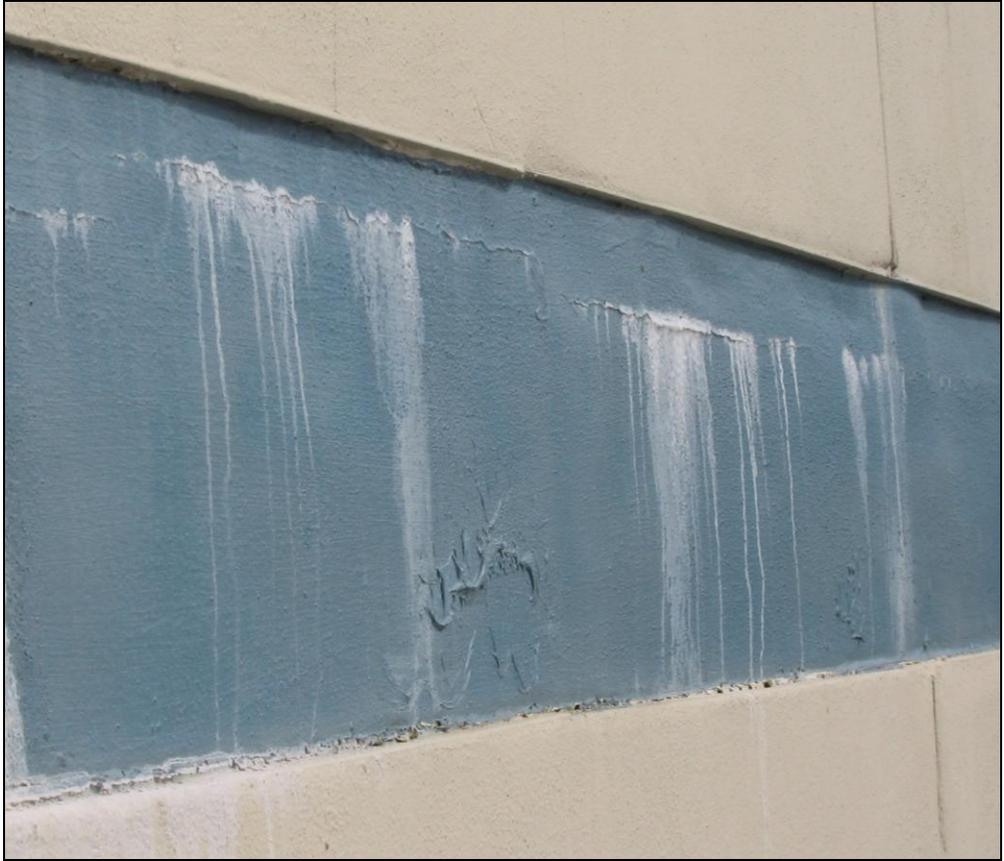
Photograph 1: Efflorescence Due to Water Seeping Through Stucco

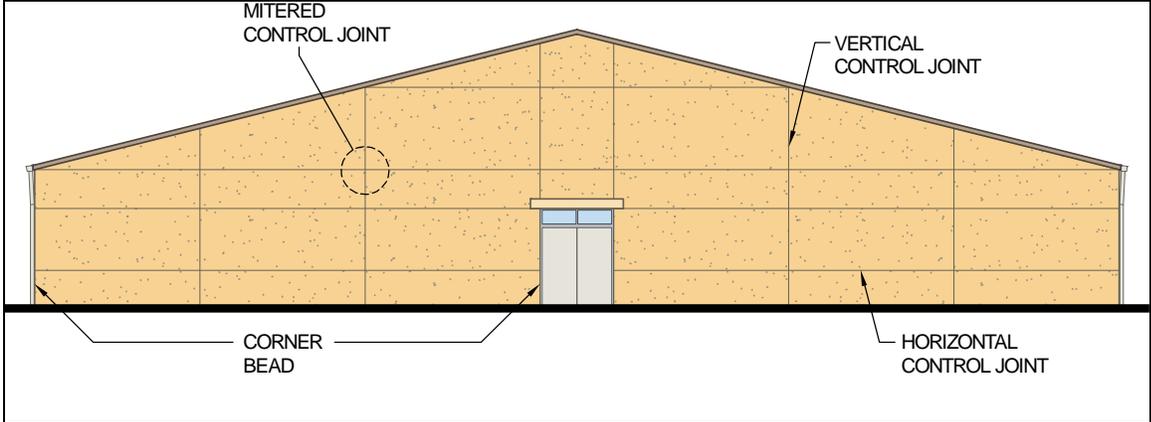
Drawing 4: Typical Arrangement of Control Joints

Application of stucco typically starts with the installation of accessories, such as corner beads and control joints, which define transitions and divide a wall area into smaller segments to control cracking. **Drawing 4** shows a typical arrangement of control joints. Stucco accessories also provide grounds used to determine stucco thickness. These accessories are made of zinc, galvanized steel, or plastic. In coastal areas of Florida, zinc or plastic is preferred to resist corrosion due to chloride contamination from sea water.

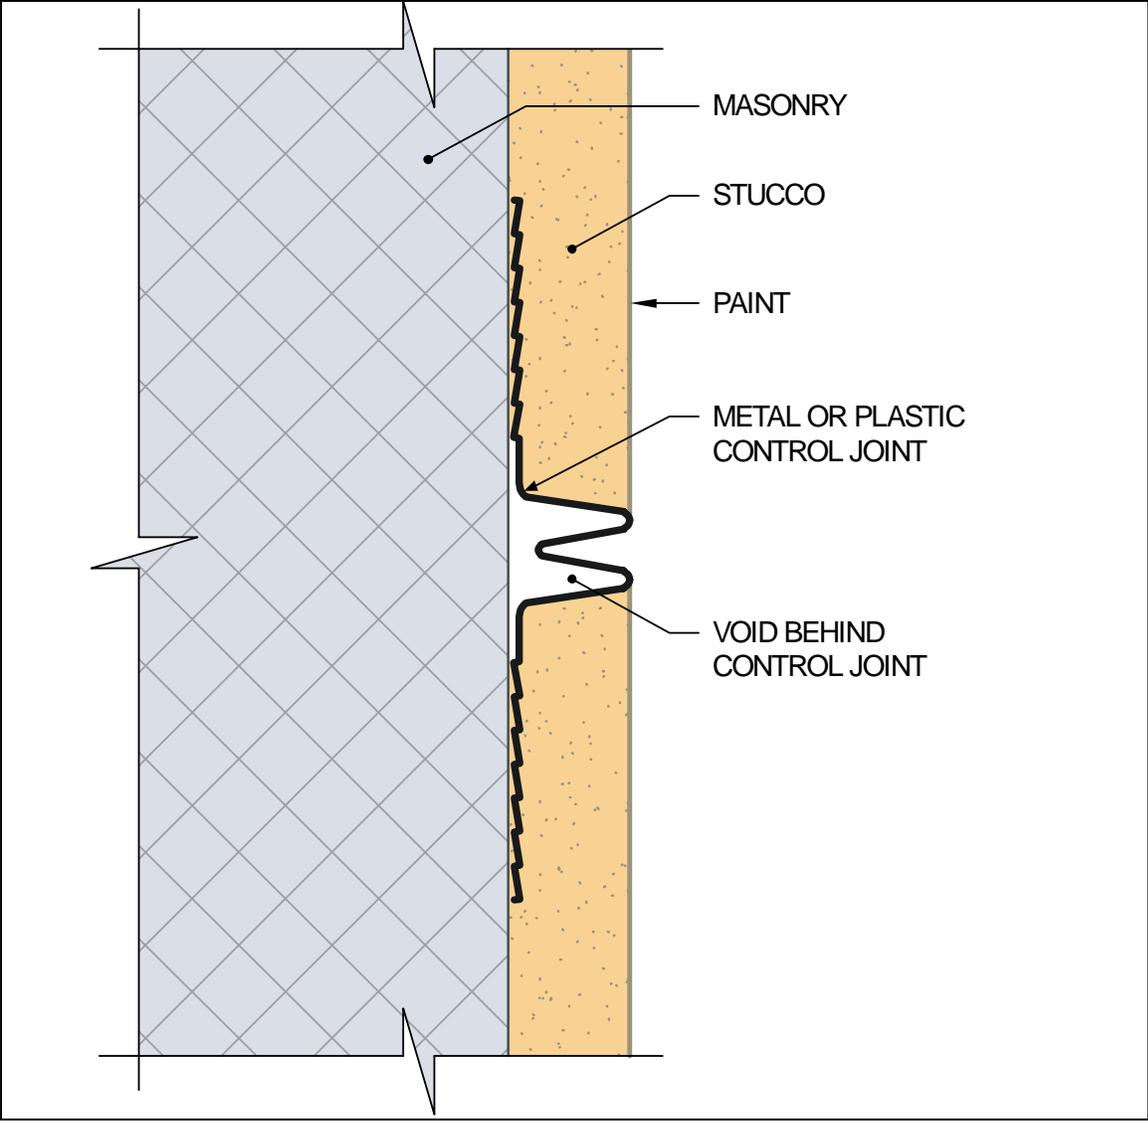
Drawing 5: Control Joint Cross Section

Some stucco accessories, such as control joints and outside corners, incorporate a void space behind the accessory as shown in **Drawing 5: Control Joint Cross Section**. This void provides a pathway for water and insect travel. In several instances, moisture transport through stucco accessories has been observed to have resulted in water intrusion into block cavities, and even through the block into the building interior.

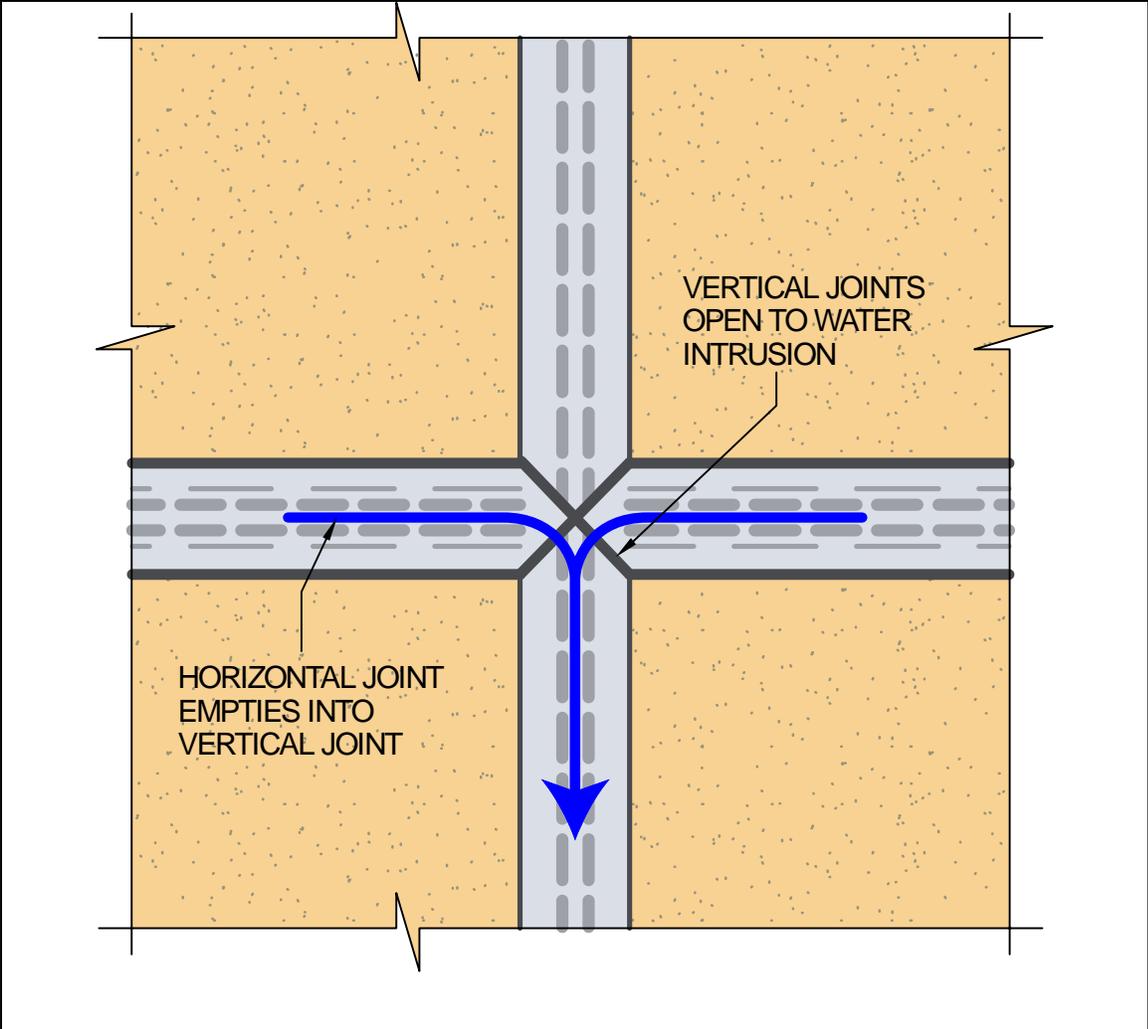
Drawing 6: Mitered Control Joint

Control joints are frequently installed to break a large wall into a pattern of squares or rectangles, resulting in vertical and horizontal joints with the inevitable intersections. Intersections can be made as mitered or coped joints. The least troublesome arrangement is for a vertical accessory to continue uninterrupted until it reaches a weather-tight termination at the top. This prevents water from entering the void behind the accessory at the top and running down the surface and into concrete block. In this instance, the horizontal runs are coped to but not cut into the vertical. It is not uncommon, however, for joints to be formed by mitering all four pieces at the intersection, as shown in **Drawing 6: Mitered Control Joint**. This arrangement not only opens the top of the vertical accessory to the weather, but also allows water collected by the horizontal accessory to drain into the open top of the vertical accessory. Typically, a sealant is daubed over the intersection, but observations of many installations have found that this is largely unsuccessful at preventing water intrusion, particularly after sealants have aged for several years. As a general observation, it was found that water penetrates behind accessories in most situations where miter joints were used between horizontal and vertical accessory runs, such as at window and door openings. Presumably, the top of the vertical accessory could be filled with sealant to prevent water entry, but this has not been observed in practice.

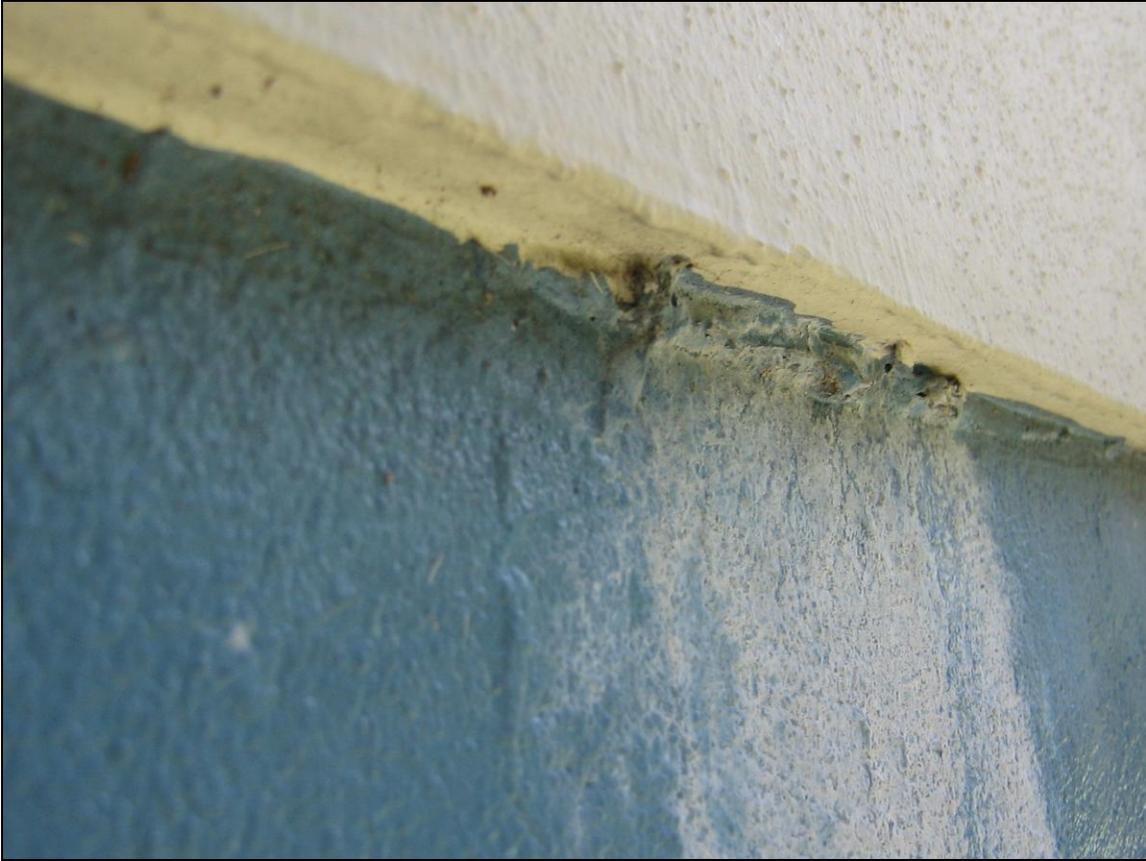
Photograph 2: Efflorescence at Accessory Joint

Water that seeps into and through stucco, as described above, contains dissolved minerals from the stucco. Horizontal accessories, such as expansion joints or J-beads, act as collectors for this water, and either concentrate water flow at joints in the accessory or dump the water down intersecting vertical accessories. **Photograph 2: Efflorescence at an Accessory Joint** illustrates the result of such a condition.

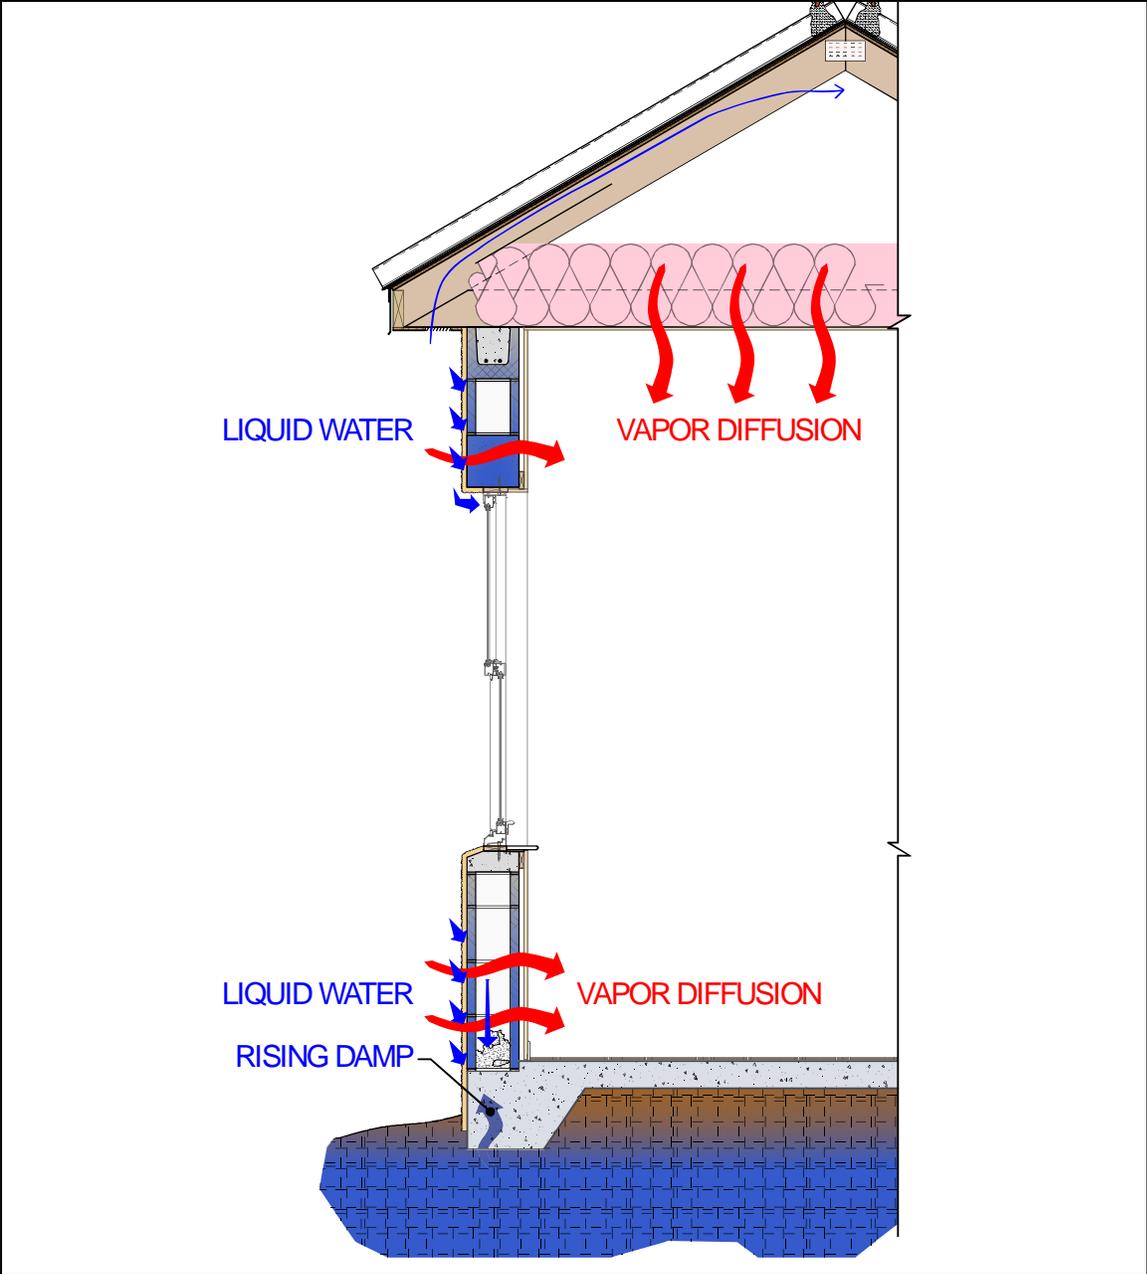
Drawing 7: Moisture Pathways in Typical Florida Building

The moisture content of materials in wall assemblies in a Florida building will vary by location and time of the year, as well as with age of the building. The overall movement of water in a typical Florida building is illustrated in **Drawing 7: Moisture Pathways in Typical Florida Building**. Water enters the building as liquid water through the outside walls, particularly at windows. This liquid water tends to descend due to gravity and collect at the bottom of walls. Air infiltration enters the wall assemblies through cracks in stucco and defects in caulking, as well as through cracks such as window joints. Water vapor diffuses through the materials comprising the exterior walls and the ceilings. The exact moisture content at any point in an envelope assembly will be the equilibrium that results from moisture added by these sources and the counteracting drying forces.

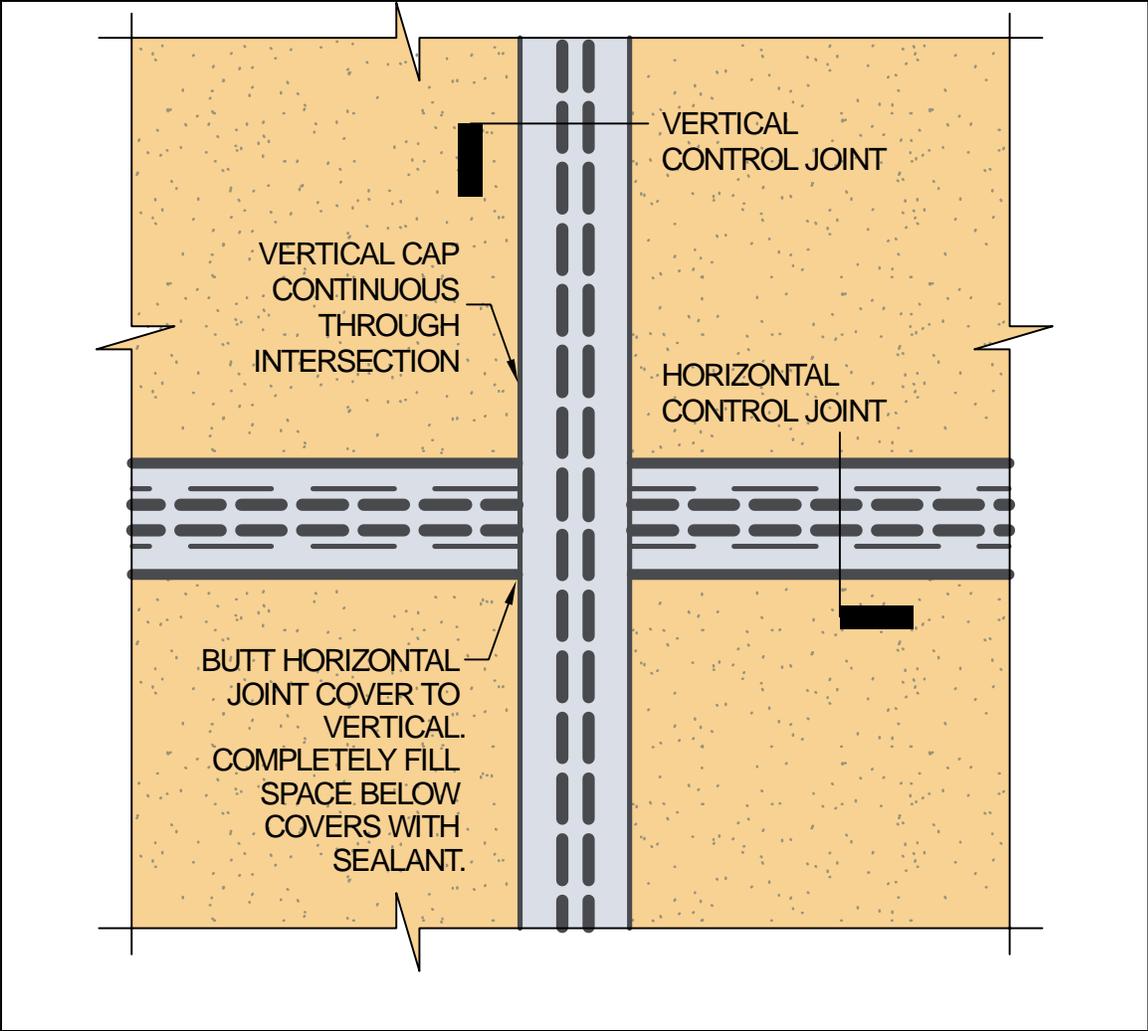
Drawing 8A: Remediation of Mitered Control Joint

**Drawings 8a, 8b, and 8c** illustrate such a remediation of the control joints in a building. Prior to the remediation, water that seeped through the stucco was collected in the void in the horizontal control joints in sufficient quantity to drain into the vertical joints, filling the joints, and then seeping into the building. Due to programming and fiscal constraints, it was not possible to correct this by replacing the stucco; therefore, the accessories were modified to sufficiently reduce water entry to resolve the water intrusion. Horizontal joints were retrofitted with a water stop and drip edge, and weep holes were installed to relieve collected water. Vertical joints were isolated from horizontal joints, and void areas were filled with low viscosity silicone sealant to prevent water entry. Another alternative would be to chop out the accessories, and install new, properly configured accessories, and then patch the stucco. While this would resolve the accessories issue, it would raise a new series of issues regarding cracking at the joint of the patch and original stucco. With this alternative, any such repair would require a follow-up evaluation and would probably require additional repair after some time in service.

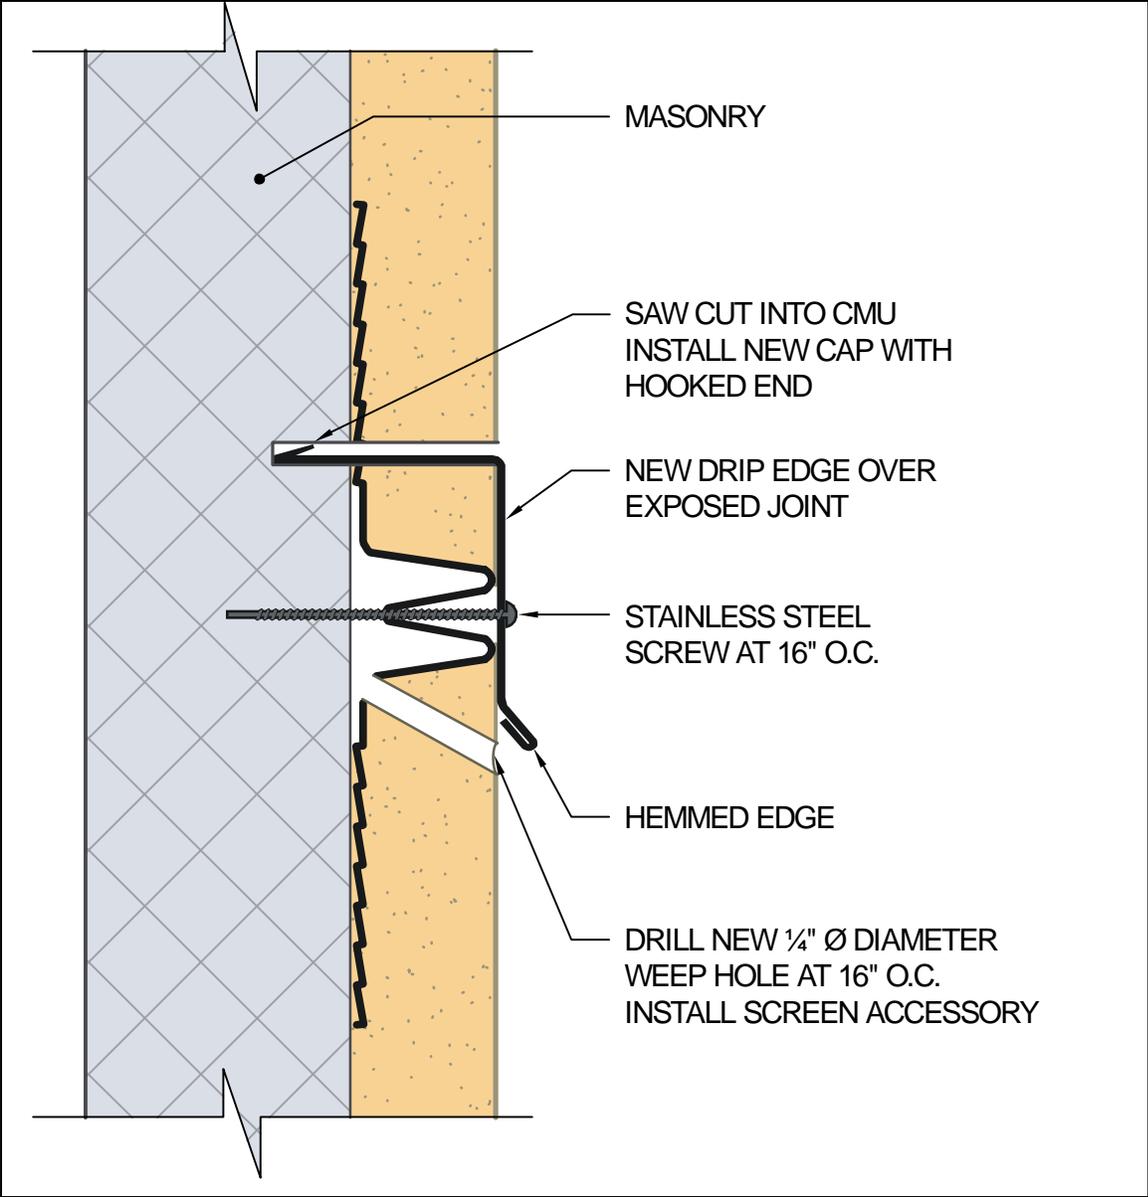
Drawing 8B: Remediation of Horizontal Control Joint

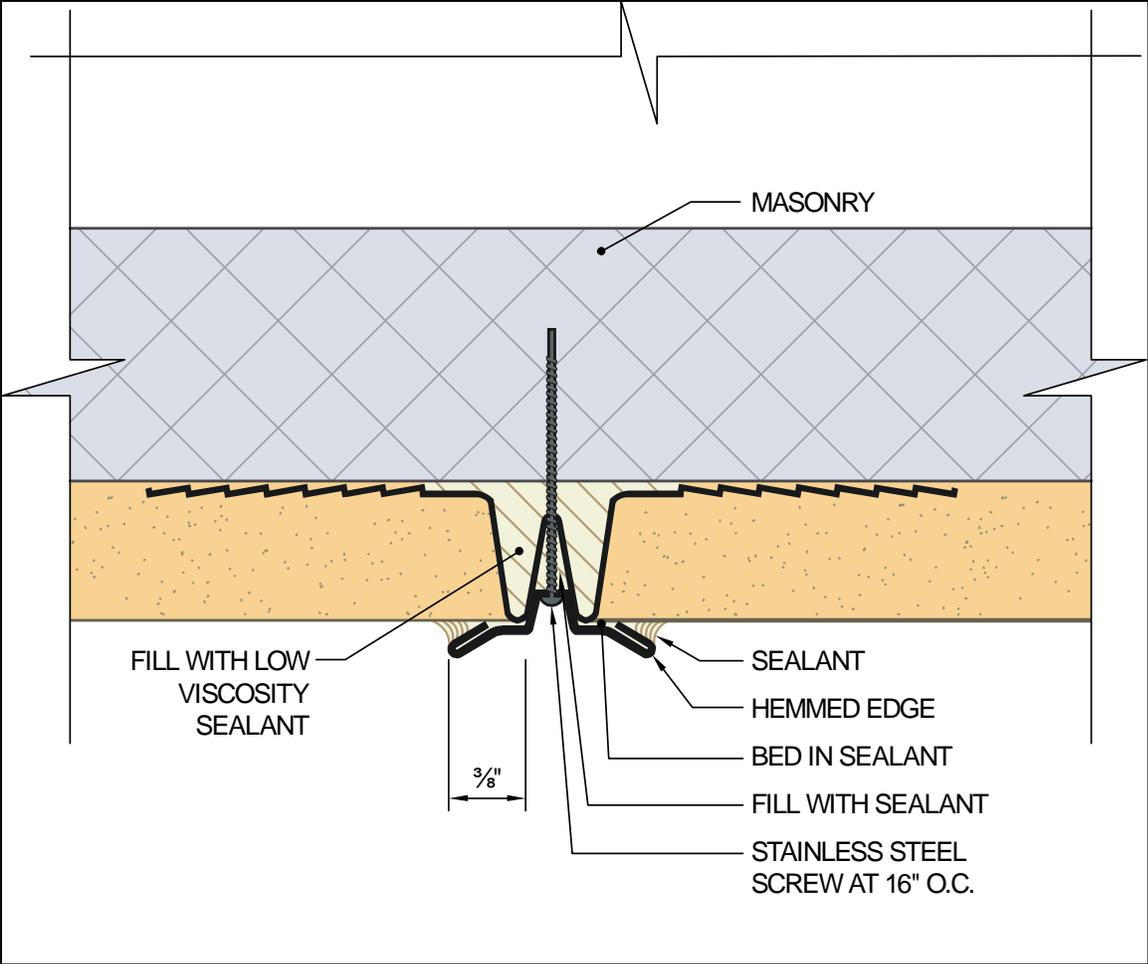
Drawing 8C: Remediation of Vertical Control Joint

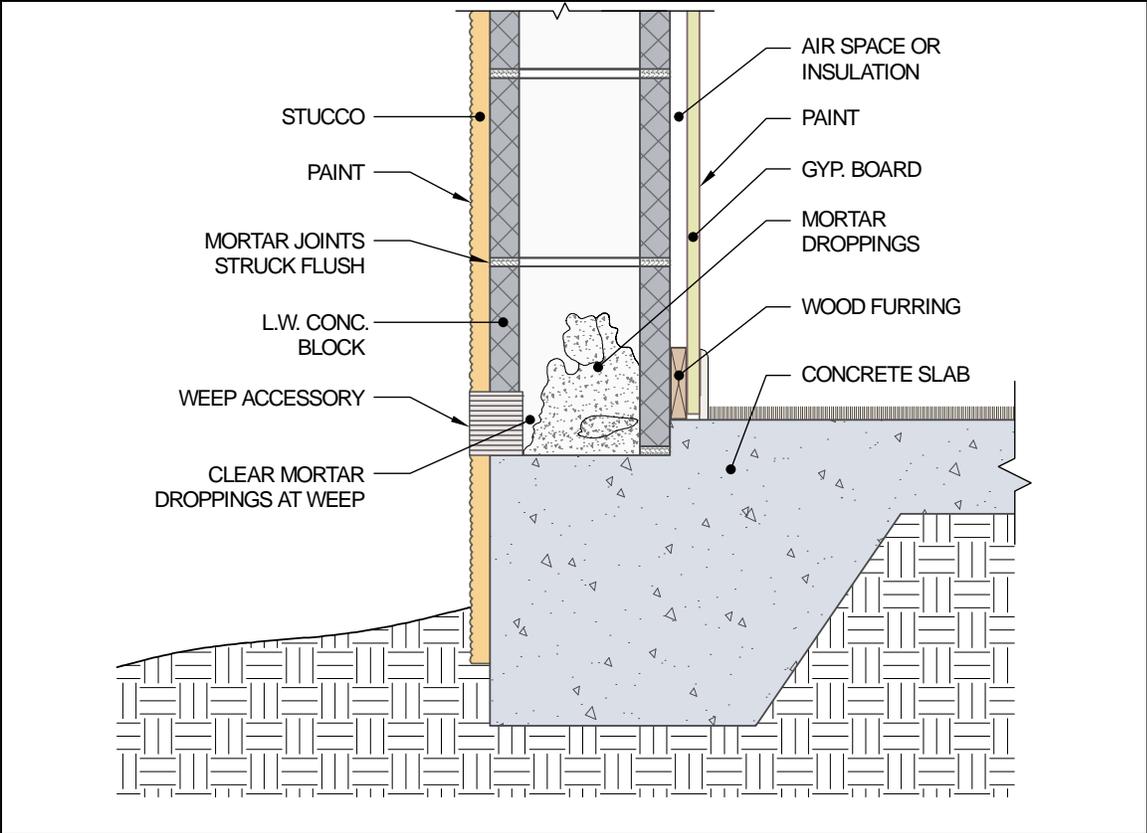
Drawing 9: Retrofit of Weep

In severe instances, water from leaking stucco and accessories may collect at the bottom of walls in sufficient volume to saturate the bottom of the wall. It may be possible to ameliorate this situation by installation of weep holes to allow bulk water to escape to the outside of the building. This improves the situation, but does not convert the wall to a proper cavity wall or drained wall system (NIBS 2010), as there is no drainage plane or through-wall flashing. In instances, however, where the downward flow of water inside the hollow block cavities is obstructed by a water-resistant structure, such as a floor, lintel, or beam, weep holes can relieve the collected water to the outside. Combined with a waterproof coating on the inside face of the masonry at the base of the wall, this scheme can ameliorate, but not completely correct, the situation where a more permanent correction is infeasible for some reason. In some instances, an impressive gusher of water has resulted when holes are initially drilled. **Drawing 9: Retrofit of Weep** illustrates installation of a weep hole in the base of a wall. Ideally such a weep will be installed at the bottom of the wall in a vertical mortar joint (head joint) below open block cells. However, with square end block, it may be necessary to cut the weep hole into a hollow cell of the block. In either case, it is necessary to clear out mortar droppings enough to allow water passage to the weep. A weep hole accessory that prevents insect entry should be used for the weep hole. Use of an accessory designed for brick masonry that is 3/8 in. wide and 2 1/4 in. high usually provides sufficient clearance to clear mortar droppings from the water path.
